# Manhole Inspection Summary

Manhole # S09GG1007MH

**Location** Address: **3622 COLUMBUS DR** Cross Street: **OAKFORD AVE**

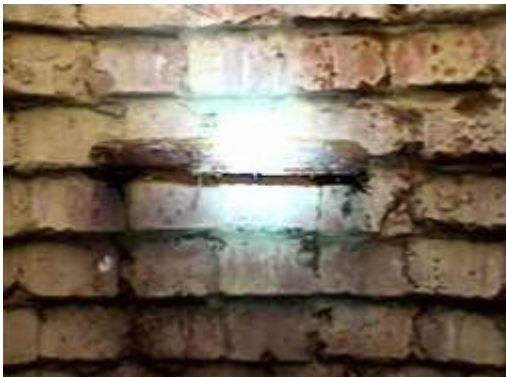
Defect 1

**Steps** Count: **3** Missing: **0** ☒ **Corroded**

CORRODED RUNG

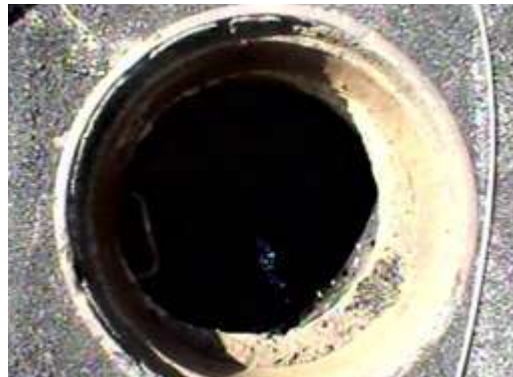
Defect 2

**Frame** Offset: **3** (in.) Condition: ☒ Sound ☐ Cracked ☐ Leaks

frame offset

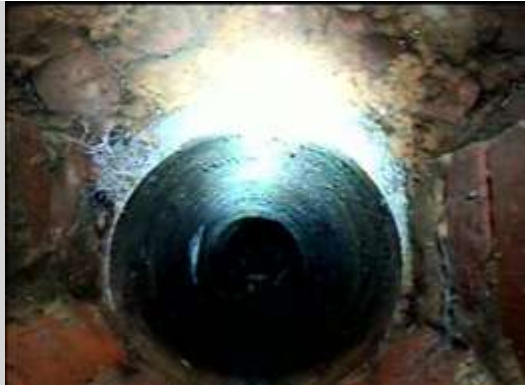
12 O'Clock Outflow

8 in. Circular Gravity Sewer  
Pipe Out @ 12 O'Clock

Invert Depth: **6.89** (ft.) Flow Characteristics: **Slow**

Infiltration: **None** Pipe Seal Cond: **Sound**

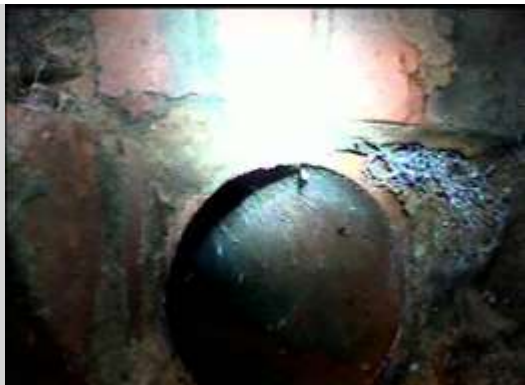
5 O'Clock Inflow

6 in. Circular Gravity Sewer  
Pipe In @ 5 O'Clock

Invert Depth: **6.80** (ft.) Flow Characteristics: **Slow**

Infiltration: **None** Pipe Seal Cond: **Sound**
